Report No. FHWA/RD-80/059

# EVALUATION OF HIGHWAY CULVERT COATING PERFORMANCE

June 1980  
Final Report

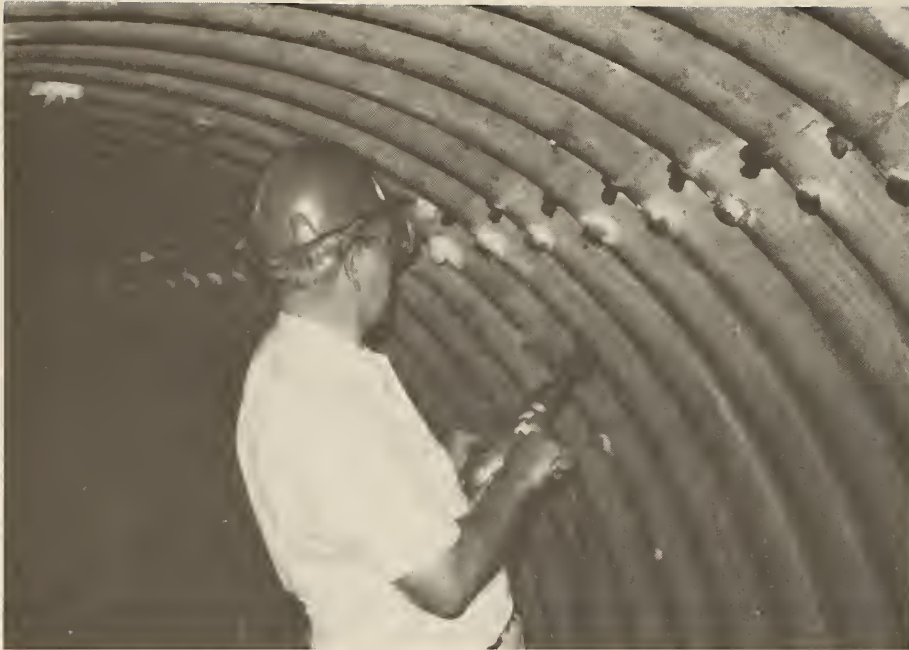
FIGURE 1 - Removing Core Sample From Culvert  
to Inspect Exterior Coating

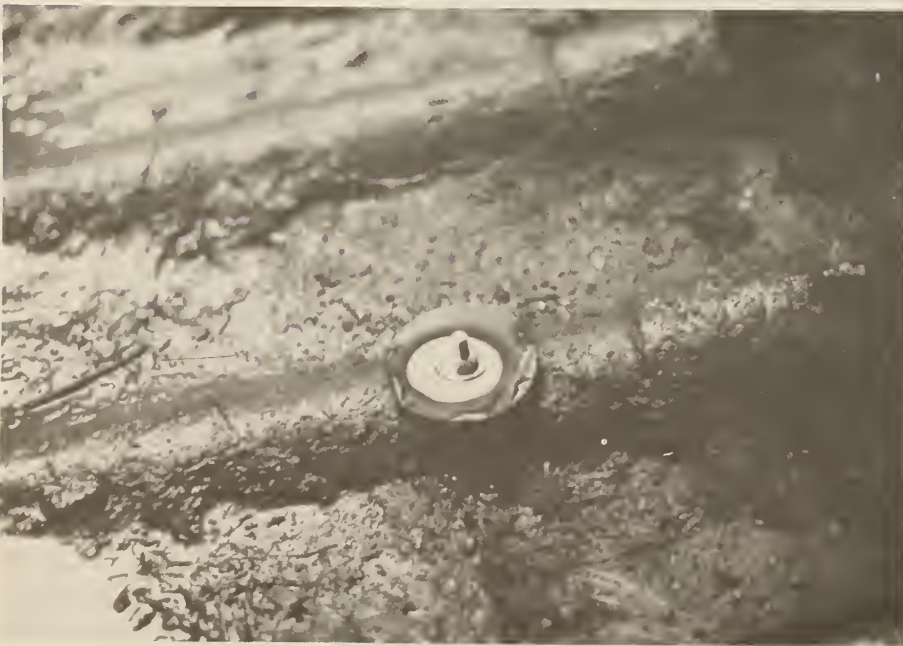
FIGURE 2 - Expandable Rubber Plug Used to  
Seal Core Hole

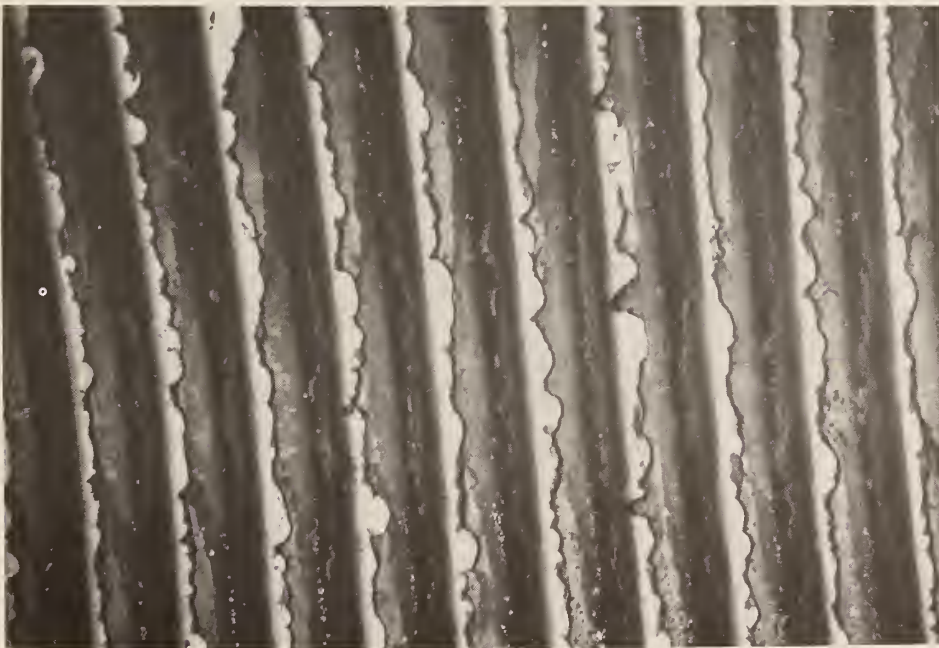
FIGURE 12 - Asphalt. Site No. 62

apparently the result of high chloride and sulfate concentrations in the water. Test samples in Louisiana show extensive damage to asphalt dipped galvanized steel when subjected to a non-abrasive environment containing chlorides and sulfates (numbers 67, 68). Figure 12 illustrates a pure abrasion failure on a 2 year old steeply sloped culvert in California. There was no water flow at the time but the maximum flow level was indicated to be one-half the 1.52 m (60-inch) diameter with rocks up to 6-inches and other debris visible. We performed a coating thickness profile on the downstream side of the corrugations and found a definite erosion loss on the invert. Mean coating thickness on the unaffected portions was .148 cm (.058-inch) whereas in the abraded portion, the thickness was .115 cm (.045-inch). The zinc had eroded away on the upstream side of the corrugations sufficiently for general corrosion of the steel to occur. Figure 13 illustrates a debris crib used at one site. Unfortunately, as Figure 14 shows, this design is unsuccessful in preventing abrasion damage. Corrosive conditions affecting the culverts shown in Figures 10, 11, 13 and 14 could not have appreciably influenced the invert coating deterioration.

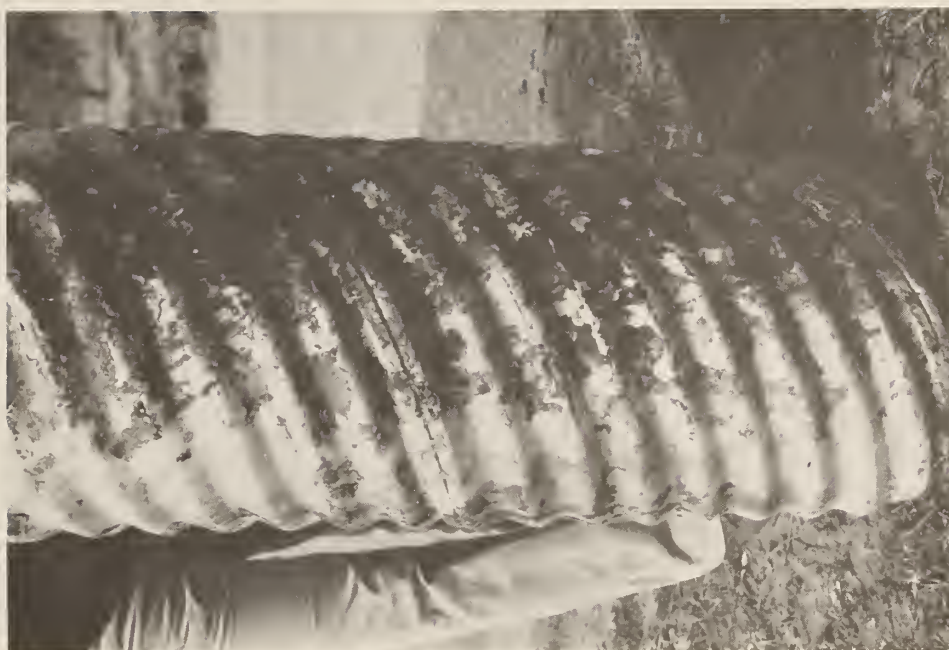
FIGURE 19 - Asphalt Coated Aluminum.  
Site No. 79

Inspections included only four asphalt coated aluminum culverts (two at test sites). Figure 18 shows a three year old aluminum coated culvert which was installed with a settling basin at the inlet. Some chipping of the coating is seen on the invert. Coatings on both aluminum culverts examined in field use were in good condition with little coating deterioration and no corrosion of the aluminum. Abrasion and rapid stream flows did not appear to be factors in the two culverts examined. Asphalt exhibits a poor bond to aluminum, being easily removed by prying. Figure 19 shows a test culvert from Louisiana exposed to a moderately corrosive environment in which almost no coating remains. While the condition in Figure 19 could be the result of periodic removals during inspections, it does illustrate the poor adhesion between aluminum and asphalt when conventional application techniques are used.

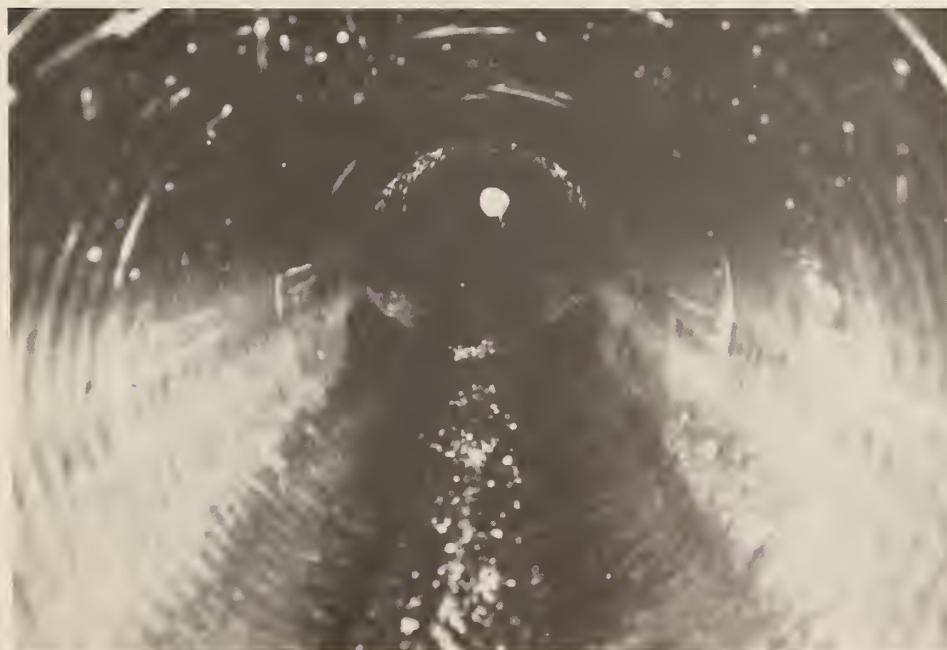
FIGURE 20 - Asbestos Bonded Asphalt.  
Site No. 28

Figure 20 shows an unpaved culvert where the coating was removed from the upstream side of the corrugations. Stream velocity was important in coating deterioration as the coating was intact where the stream velocity decreased near the outlet. Figure 21 shows the interior of a culvert exposed to waters with a high salt concentration. The asphalt has delaminated from the saturated asbestos layer at and below the water level. Layer type corrosion is occurring on the steel. In many areas, although the asphalt has been removed, the steel is not corroded, being protected by the asphalt impregnated asbestos and zinc. This observation was made at several other locations. Figure 23 illustrates the asphalt delamination in alkali soil conditions at the Utah test site but no corrosion of the steel. Figure 22 shows an asbestos bonded asphalt coated test culvert exposed to brackish water from Louisiana's Hackberry test site. No significant coating deterioration was observed although asphalt delamination was observed at the Starks test site (number 76). Some of the delamination at the test sites might be the result of periodic removal operations but could also be the result of freeze thaw cycling. Adhesion of the asphalt to the substrate varied, but the mode of failure always consisted of tearing of the asbestos layer.

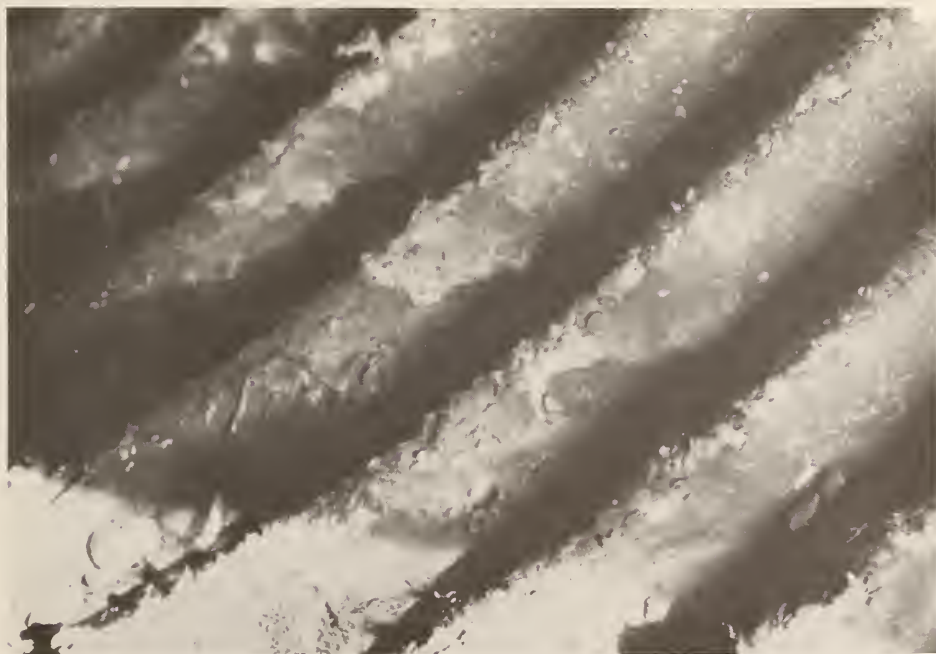
FIGURE 24 - Coal Tar Laminate. Site No. 12

Coal tar laminate (U.S. Steel Nexon) exhibits good performance except under abrasive stream flows and in low pH and high salt environments. Figure 24 illustrates the beginnings of abrasive damage at corrugation crests. This particular culvert is in the Genesee Expressway (I-390) in New York and was about a year old when inspected. Most of the damage occurred during construction when angular shale passed through the culvert. Figure 25 shows a more advanced stage of erosion on a six year old culvert with a strongly

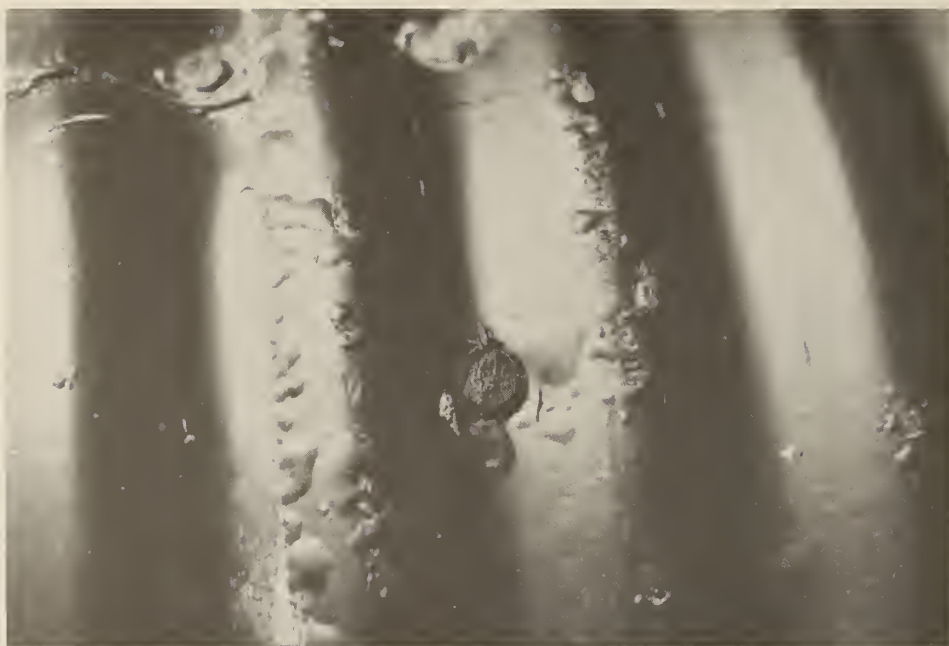
FIGURE 29 - Coal Tar Laminate. Site No. 66

Figure 29 shows a coal tar laminate coated test culvert exposed to brackish waters at the Louisiana Hackberry test site for six years. General blistering is occurring over the entire surface although it is more severe at uncoated cut edges and coating defects. Similar blistering and disbondment at edges and the lock seam were observed in alkali soils at two Colorado test sites (No. 45, 48) but were not observed in the alkali soil of the Utah test site (No. 39). The major difference between the Louisiana, Colorado and Utah test sites is the greater chloride content at the Colorado and Louisiana test sites (see Tables III-IV).

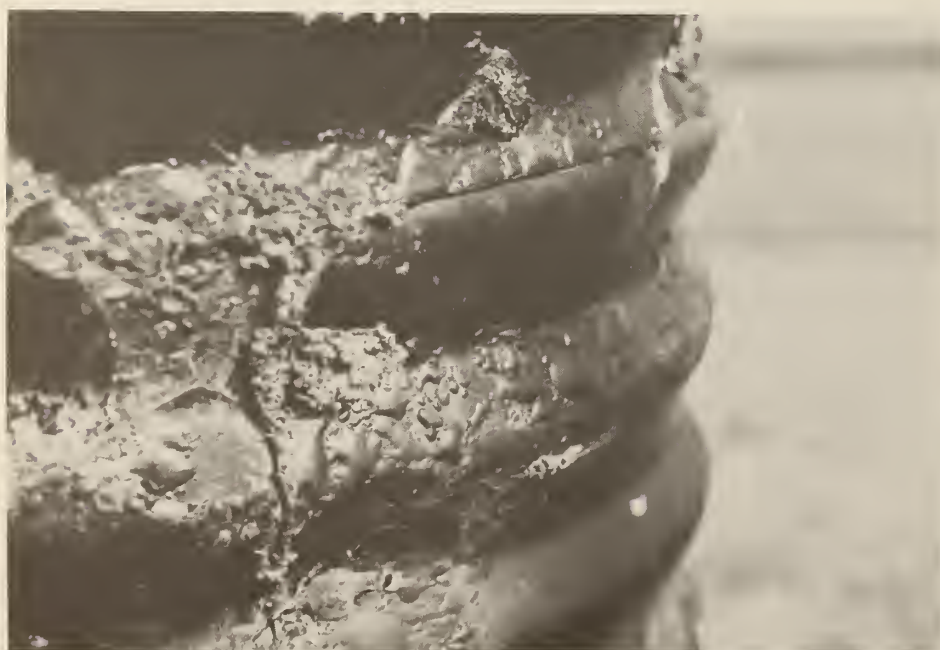
FIGURE 30 - Polyethylene. Site No. 70

Polyethylene (Inland Black Klad) coated culverts were examined at test sites in Colorado, Kentucky and Louisiana. Figure 30 illustrates a sample removed from the brackish Louisiana Hackberry test site (No. 69, 70) and shows extensive general blistering and disbondment. Minor blistering was observed at coating discontinuities at the mildly corrosive test site at Starks (No. 80, 81). No deterioration was noted at the Dillon, Colorado test site (No. 55). Performance in the acidic waters of Kentucky's Mortons Gap test site (No. 94) is satisfactory except for some disbondment at uncoated edges.

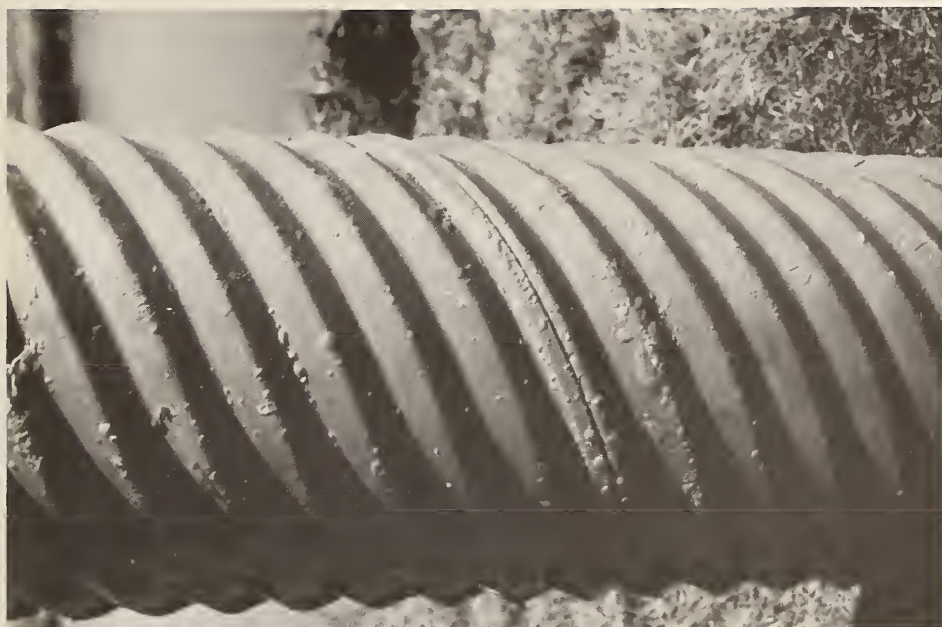
FIGURE 31 - PVC. Site No. 71

Polyvinyl Chloride (PVC) as manufactured by Wheeling Steel Company (Plasti-Cote) coated culverts were inspected at test sites in Colorado and Louisiana. PVC coating performance is similar to polyethylene, developing blisters over the surface in areas with high chloride content. Figure 31 shows a PVC coated test culvert removed from Louisiana's Hackberry test site (No. 71). Minor blistering at the lockseam was also found at the two Colorado test sites at Fruita and Olathe (No. 46, 49). Significant deterioration was not

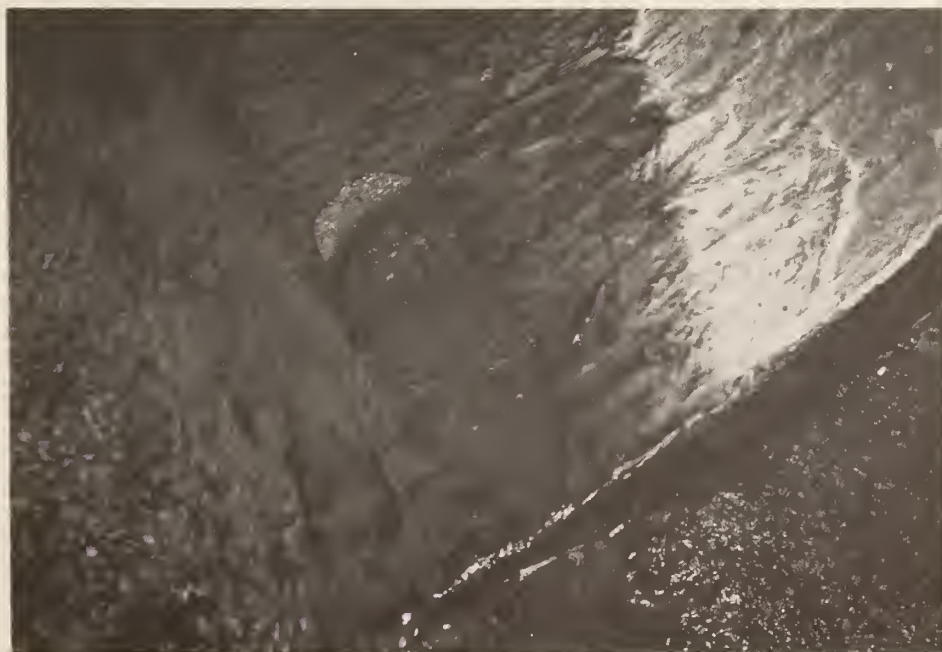
FIGURE 32 - Coal Tar Epoxy on Concrete.  
Site No. 1

Epoxy coatings applied to concrete culverts seem to be successful in protecting the concrete substrate. Figure 32 illustrates a culvert with a coal tar epoxy invert coating. A few areas were disbonded on this invert but the coating was otherwise in good condition. Figure 33 shows a polyamide epoxy invert coating which did not exhibit deterioration. This particular coating contains a sand filler which might improve its erosion resistance. The stream can erode the concrete and undercut the coating as in number 87 in Table IV if the paving does not cover a sufficient portion of the pipe circumference to shield the concrete during normal stream flow conditions. The coated concrete culverts examined were not exposed to abrasive flow or rapidly moving water so that performance under these conditions can not be documented here. An epoxy coated culvert exposed to rapid water movement and abrasion (number 31, Table IV) was given only a cursory examination because of rapid water flow and volume. The epoxy appeared to be intact after 3 years.

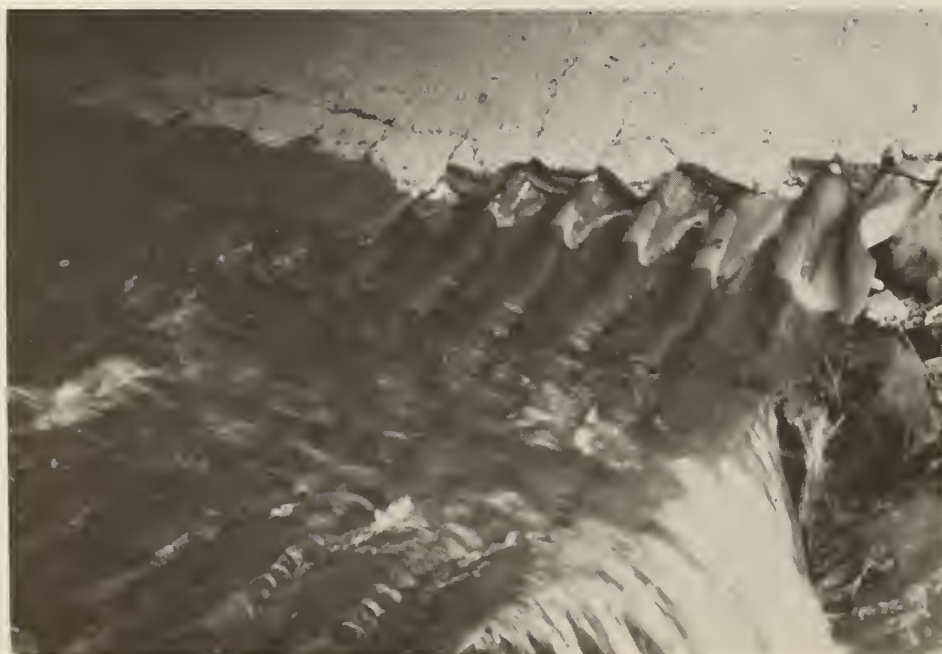
FIGURE 34 - Gunite on Galvanized Steel.  
Site No. 92

Gunite paving was found to be unsatisfactory in acidic flows. The gunite paving that we examined appeared to have broken loose from the corrugated steel. There was no reinforcing used and this might have helped retain the paving. Figure 34 illustrates the type of deterioration observed on gunite paving.

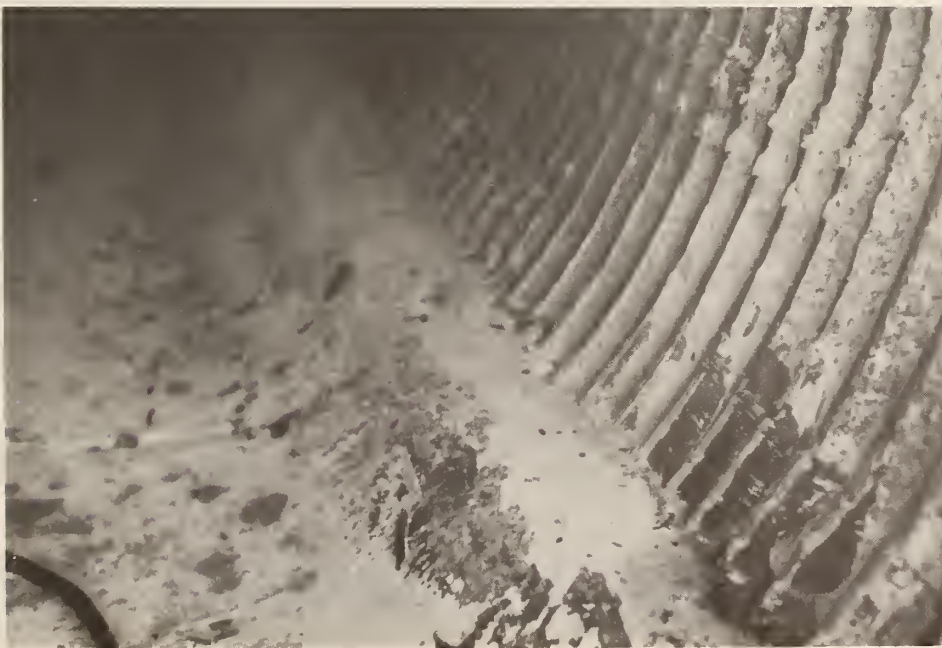
FIGURE 36 - Concrete on Asbestos Bonded  
Asphalt. Site No. 34

Figure 36 shows a concrete paved culvert applied over asbestos bonded asphalt. The concrete is probably reinforced according to Utah specifications. No deterioration was observed, however, the culvert is exposed to only intermittent flow.
